SERVICE BULLETIN – 2003/01

Subject : Positioning Tube Reinforcement

System: M1022-A1 Dolly Set Mobilizers

Reference Document: US Army Modification Work Order MWO 9-2330-390-35-1

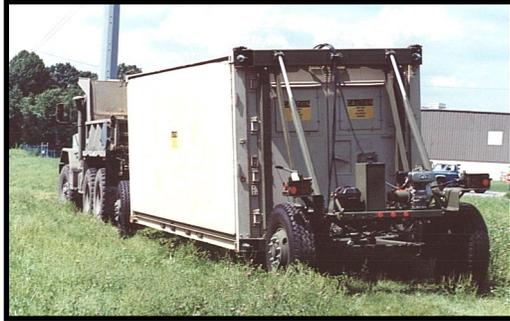
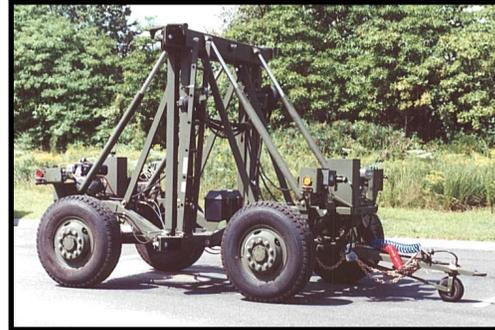
The referenced US Army MWO prescribes an approved modification to fielded M1022-A1 Dolly Set Mobilizers that exhibit evidence of cracking in the weld areas where the vertical telescopic tubes (that hold the positioning cylinders) meet the upper and lower horizontal beams. (Note: a separate inspection procedure is available upon request to identify if the problem exists, and to identify if it is severe enough to warrant this modification.)

The MWO requires the dolly set to be disassembled, then the eight vertical steel tubes are cut off from the upper and lower frames on both the front and rear dollies. Eight new brackets are then welded in their place, and new vertical tubes are pinned to the brackets in place of the old tubes, thus eliminating a welded joint in this area. To provide lateral stability, new steel cables are also added between the upper beam and vertical tubes. The affected beam area then needs to be re-painted, and the system re-assembled and checked for proper operation.
